Repairing the audio amplifier

This one came to me from a co-worker. It had a "rattle" inside and did not power up. The importance of trouble shooting does become obvious with this repair.

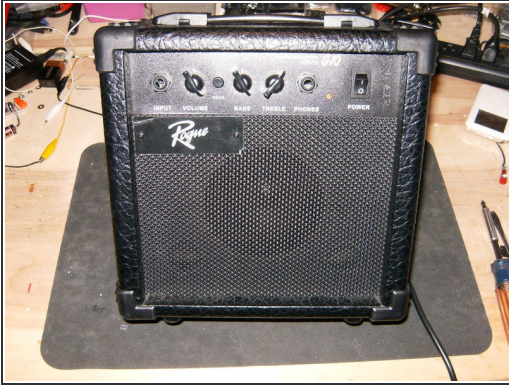
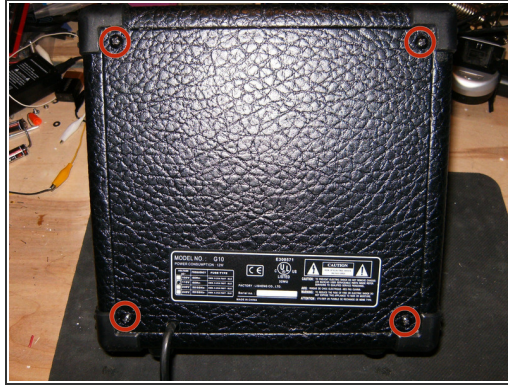
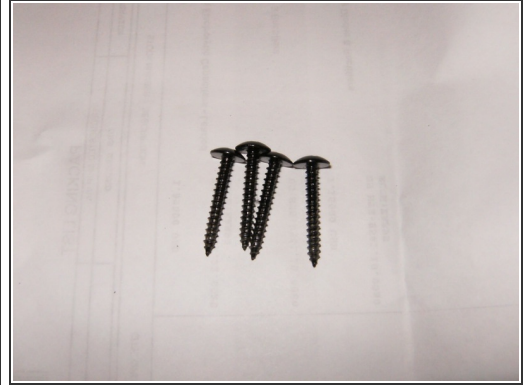
Step 1 — Repairing the audio amplifier

- Here is the Amp in all its miniature glory. total size is 9 1/2 inches X 9 5/8 inches and 6 inches deep. All controls are in the front panel.
- Remove the 4 Phillips head screws from the back panel.
- Here are the 4 #6x1" screws

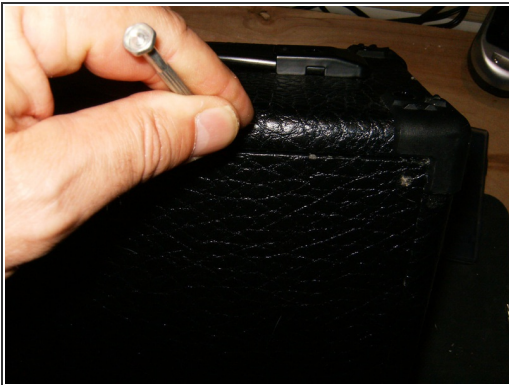
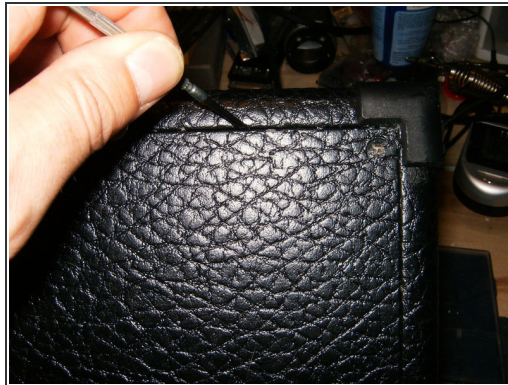
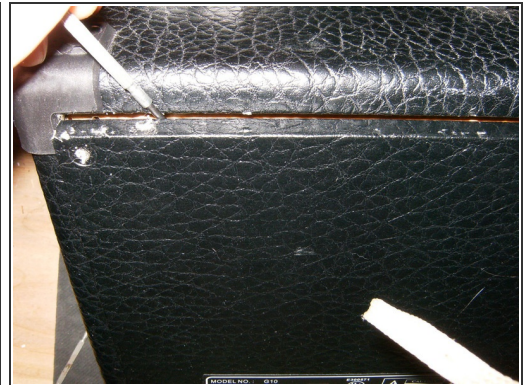
Step 2

- Remove the back panel. Use a small screwdriver, or other instrument to free it from its recess.
- Work your way all around, since the back is a bit snug in the recess.

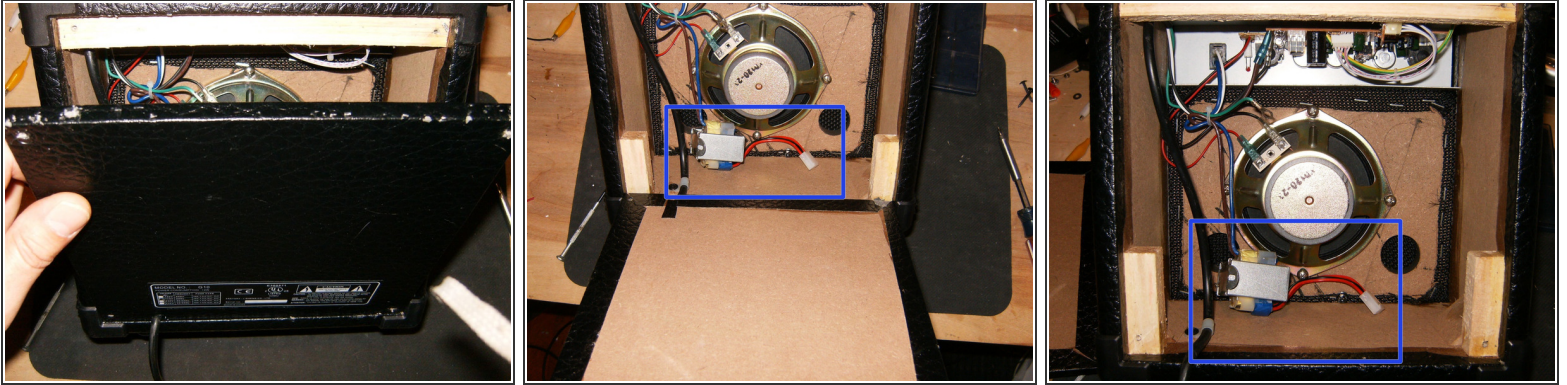
Step 3

- Once the panel is freed from the recess, fold it down and remove from amp.
- Something does not look quite right :-)
- the transformer should be mounted to the PCB, not laying inside the box.

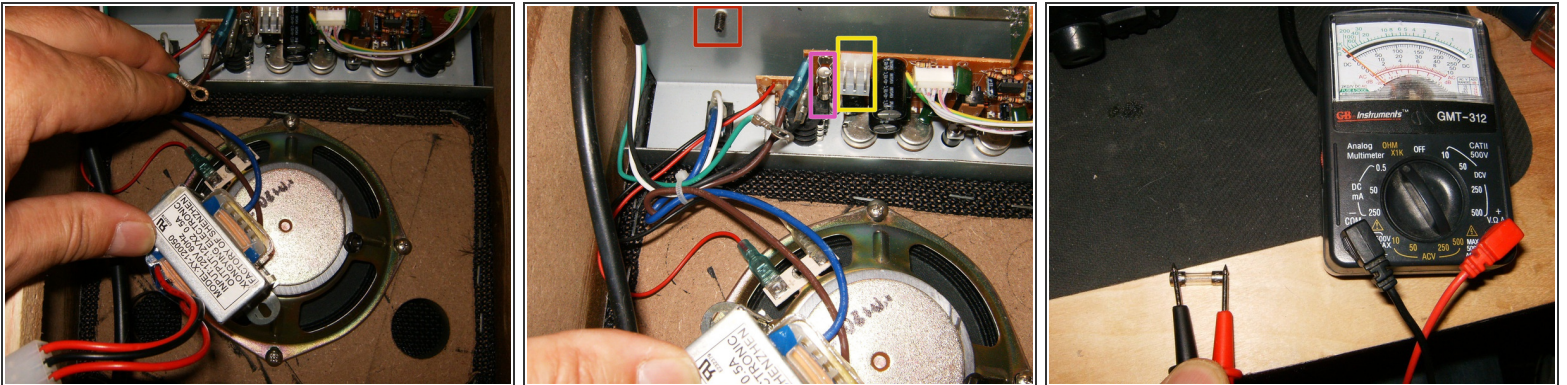
Step 4

- Trying to find a mount for it.
- Closer view of the control panel PCB.
 - Mount for the transformer
 - Unoccupied connector
 - Fuse
- Before anything else, check the fuse for continuity. this one has failed.

- Replace the fuse. Insert transformer power cable to PCB.
- Since the Amp did not turn on, check the power out on the transformer. It does show 12V DC. Reconnect it and turn the Amp face forward.
- The Amp uses a 6.3mm input and output jack. Apply a sound source to the input. Still no sound from the Amp, it is time to check a bit deeper.

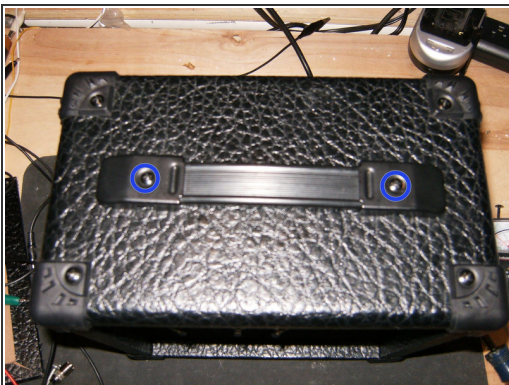
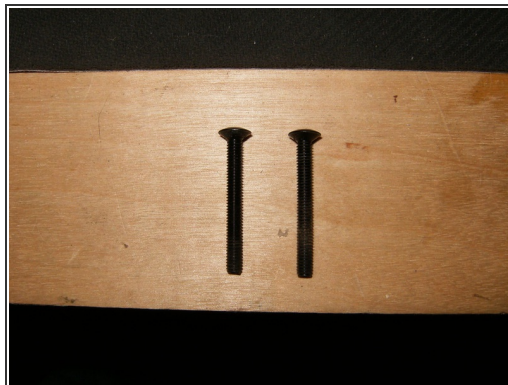
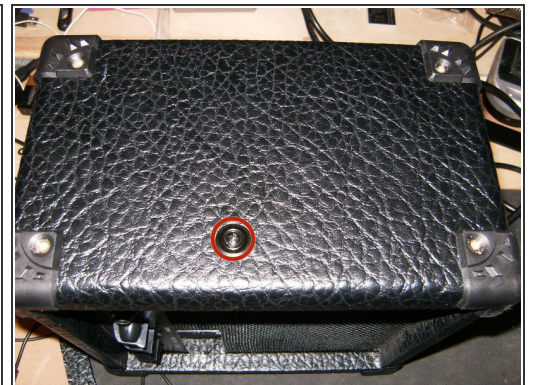
Step 6

- Remove the two Philips head screws from the carrying handle.
- Those are 3mm x40mm
- Remove the Philips screw on the right side of the Amp

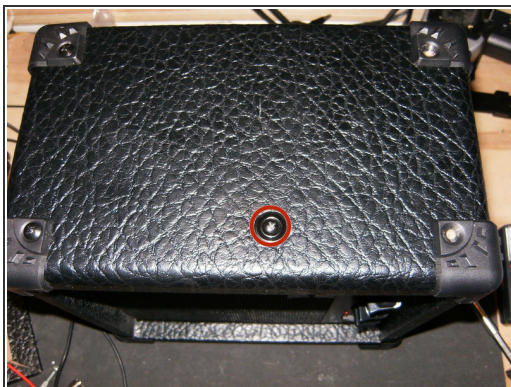
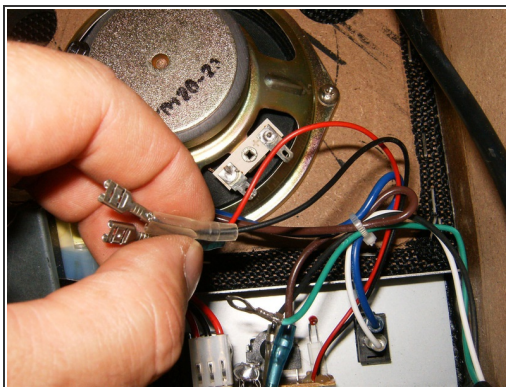
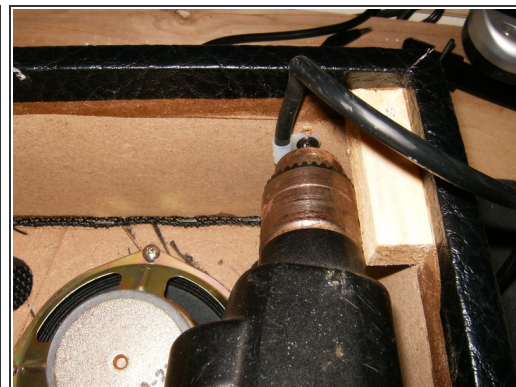
Step 7

- Remove the Philips head screw on the left side of the Amp.
- Unplug the speaker wires.
- Remove the Philips head screw that holds the power cable bracket.

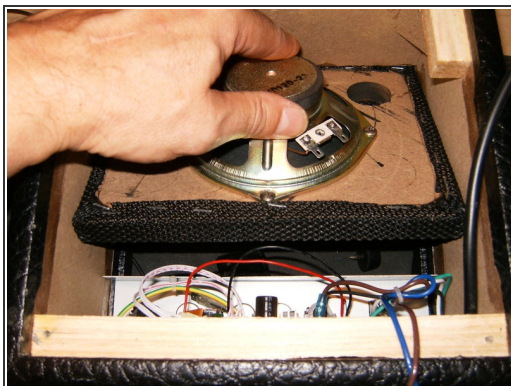
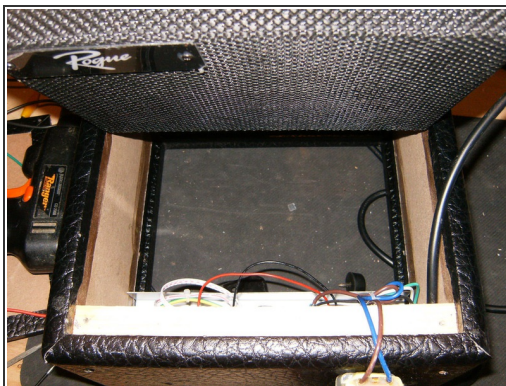
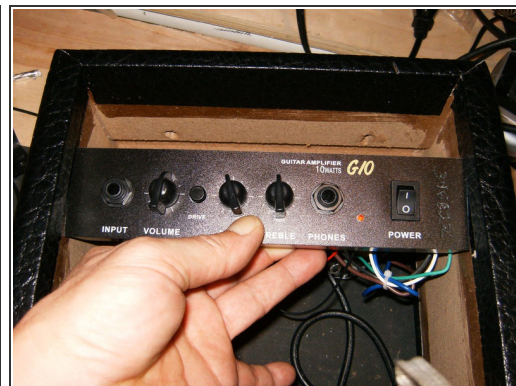
Step 8

- Remove the front panel and the attached speaker.
- Simply lift it at an angle out of the back of the Amp.
- The control panel and the attached PCB can now be removed.

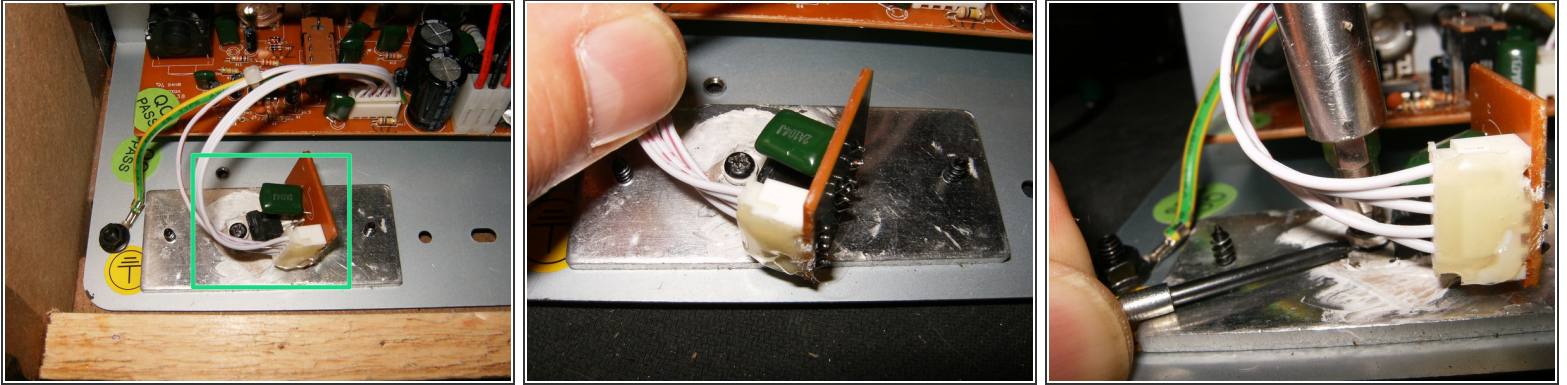
Step 9

- Another odd looking piece is the location of the power Amp IC.
- The smudge marks of the thermal past revealed that the board was loose and the the IC did not make contact with the heatsink
- The thread in the heatsink was partially stripped. Use a small jewelers screwdriver to wedge under the screw, while using a #2 Philips screwdriver to remove it.

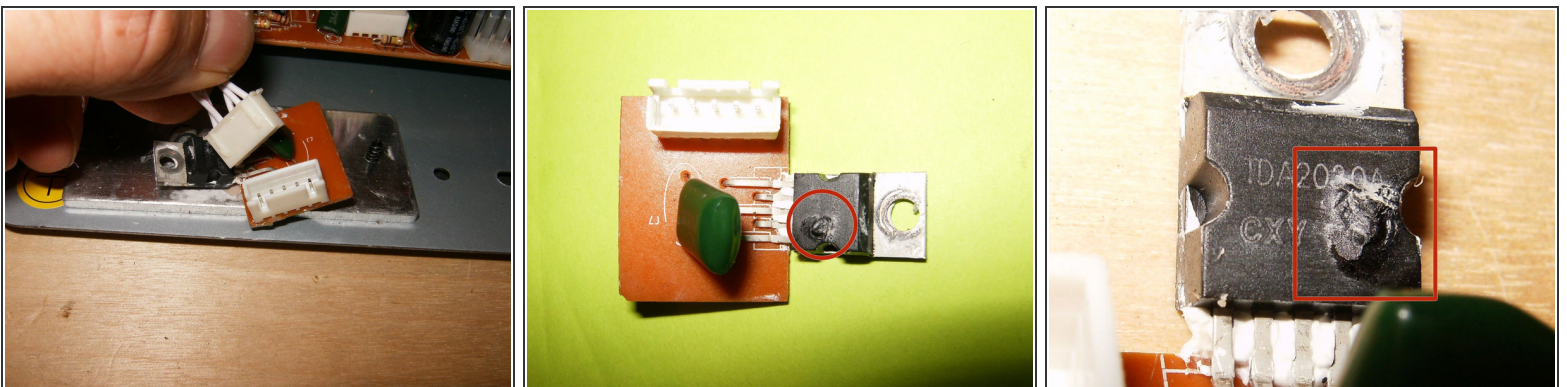
Step 10

- Remove the connector from the PCB.
- Remove the IC PCB from the panel. The IC definitely shows some damage, most likely from overheating.
- Here is a close up of the damaged IC. It is a TDA2030A 18 W hi-fi amplifier / 35 W audio driver
